CHECK YOUR TORCH

This e-mail was produced by the Institute of Scrap Recycling Industries, Inc. For more information, visit us on the Web at www.ISRI.org
For comments or suggestions about *For Your Safety*, e-mail joebateman@isri.org

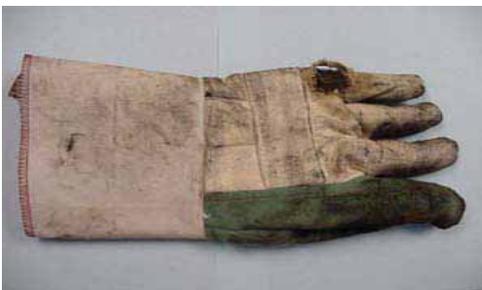
In 2004, a steel company employee's hands were severely injured when using a cutting torch. The incident involved a worker who was cutting scrap steel. After he had finished torching a piece of scrap, he used his left hand to push it into the scrap bucket. As he reached past the lighted torch (about 4" - 6" away), oxygen that had collected in his glove ignited and blew the glove off his hand. (See Figure 1.) He received first- and second-degree burns on his hand and fingers.

The incident investigation revealed that the oxygen hose had a leak either where the hose ferrule had been crimped or a few inches downstream. The major root cause findings were that oxygen had been leaking from the hose and that the worker did not inspect the torch for leaks before using it. The incident investigation also revealed that the hose ferrule had been crimped with the wrong die. After the accident, the company identified an inexpensive and effective solution for identifying these leaks.

Figure 1. Glove damaged by leaking torch

The company instituted an inspection process for workers to verify that all torch components are in proper working order. Before an operator uses a torch, he inspects it, the hoses, connections and valves. The operator inspection process is just one form of a safe work habit that reflects positively in employees' overall safety attitude and makes for a safer work environment.

The operator inspection process includes spraying the hose and all torch fittings, connectors, weld piping and gauge end fittings with a solution of soap and water pumped out of a plastic spray bottle costing less than \$2.00. The company keeps a spray bottle clearly marked "Soap and Water" at every torch station. When the soap and water solution is sprayed on a torch and hits a leak, it bubbles. If the hose is under pressure, the test results are immediate. (See Figure 2.) The company uses only soap and water testing solutions that are approved for use by equipment manufacturers because incompatible solutions can lead to corrosion of the cylinder valve and cutting hose. Leaky hoses and fittings are not always repairable and may need to be replaced when a leak is detected.

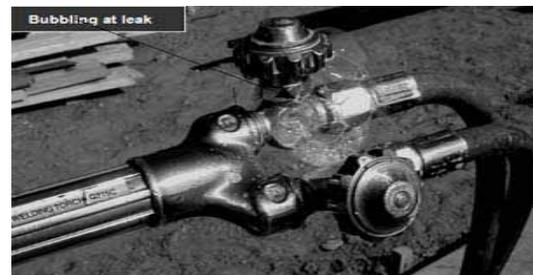
Figure 2. Bubbling at leak
